# **The Owner's Guide to Piano Repair**

## **Focus On: Replacement of Worn Asian-Design Hammer Butts and Flanges**

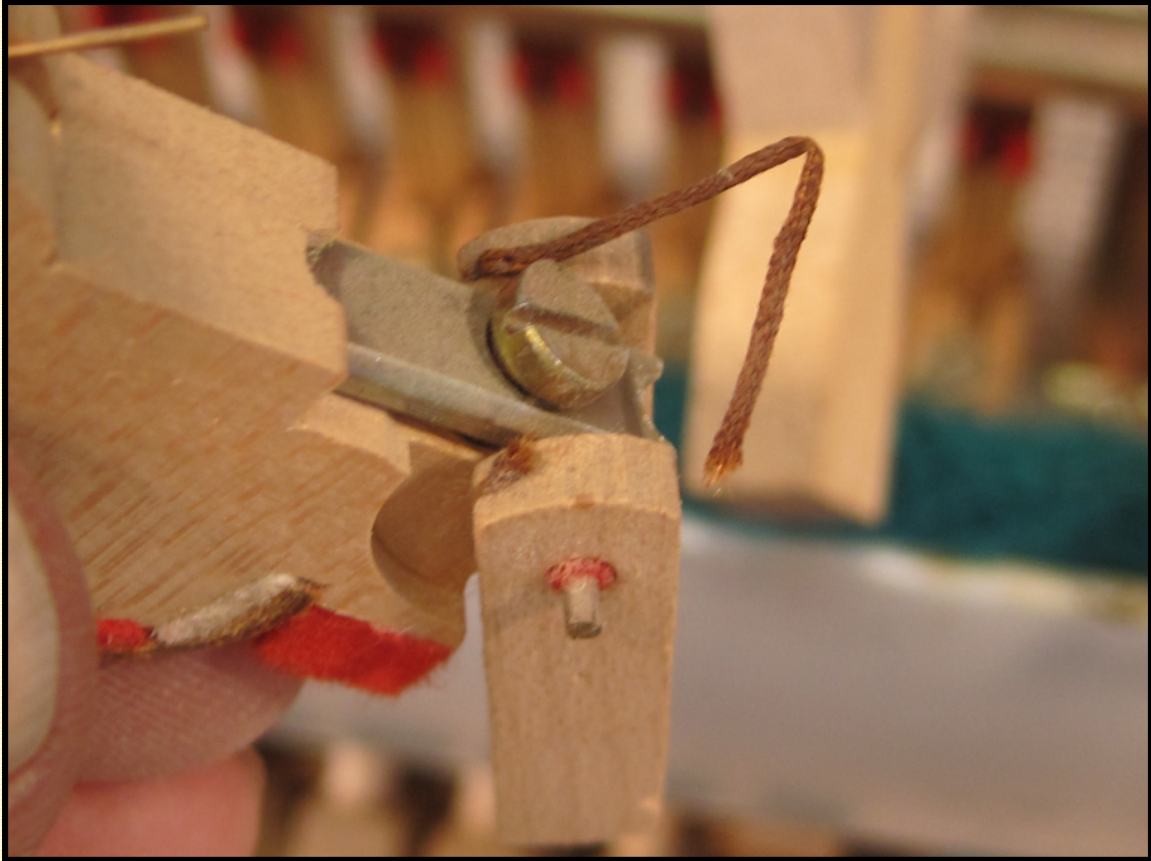
The Achilles heel of Yamaha, Kawai and other Asian-made pianos is a hammer butt assembly that relies upon a small braided cord to hold an essential spring in check. After years of use this cord is prone to breaking (as shown in photo on cover), which causes the piano action to perform unsatisfactorily.

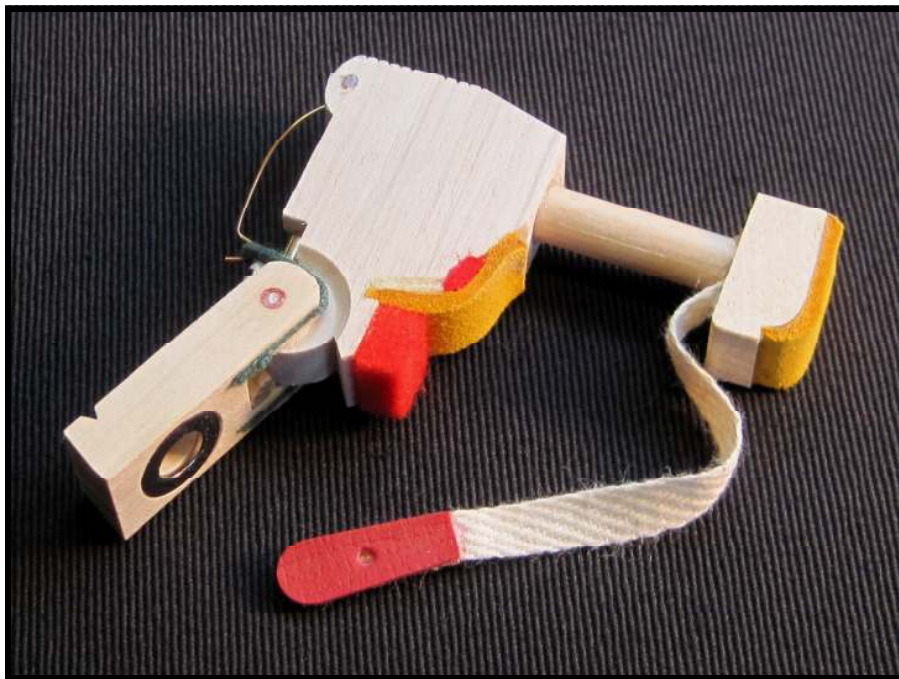
*A new Asian-design hammer butt / flange assembly ready to install.*

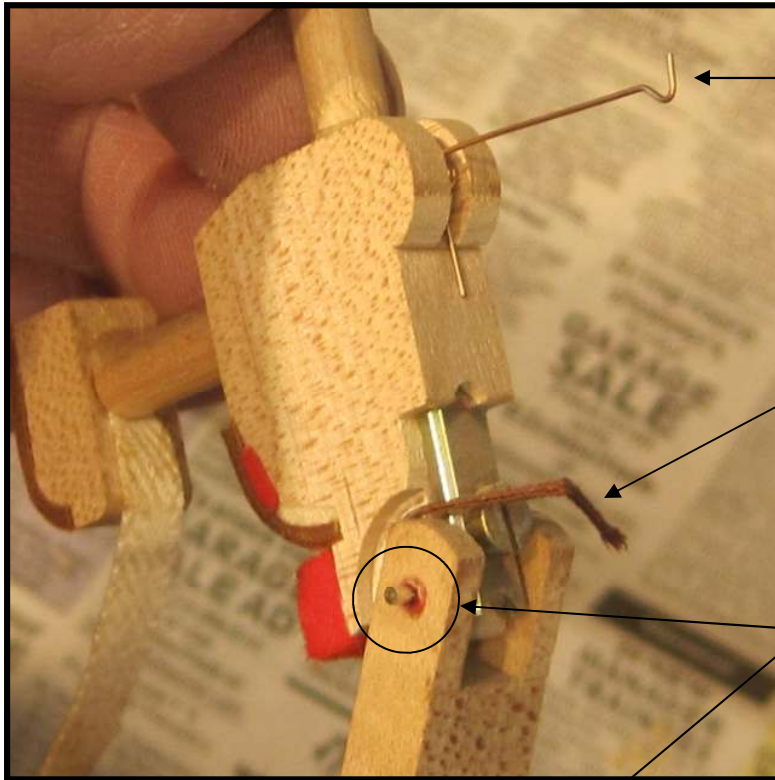
The following photos of used hammer butt / flange assemblies from a 1980s Yamaha studio upright illustrate the most common problem areas.

**Hammer butt return spring:** When held in check by the flange cord, this spring swiftly returns the hammer butt to its rest position so that it's ready to fire again the next time the note is played.

**Flange cord:** Although strong enough to hold the continuous tension of the return spring for decades, it eventually can give out and break.

**Action center:** The pivot point for the hammer butt. As the felt bushing and brass pin become worn, the fit of the pin loosens, causing sloppy play. The pins in the photos have worked loose entirely from one side of the flange, causing extreme wobble.

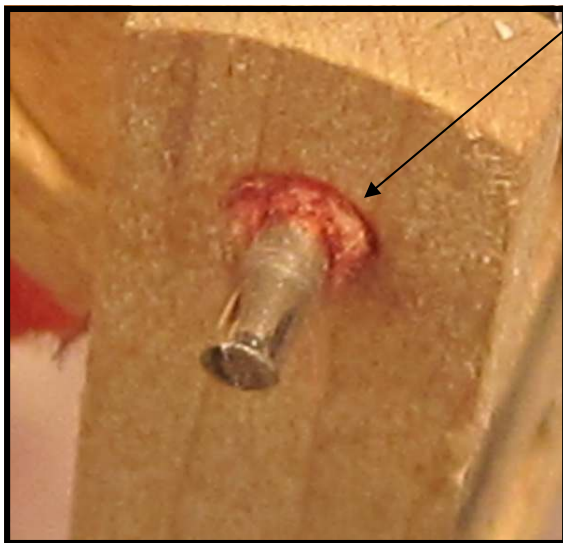
Although less obvious than broken flange cords, loose action centers also cause problems for the performance of the piano. Ordinarily, wear and tear of the felt bushing is the cause of overly loose action centers, but sometimes the brass pins themselves begin to wear away, as in the photo to the left. When an action center has thus loosened up, hammers wobble on their way up to the strings, striking less than a solid blow. In extreme cases, hammers may go off course to the point where they hit the wrong strings!

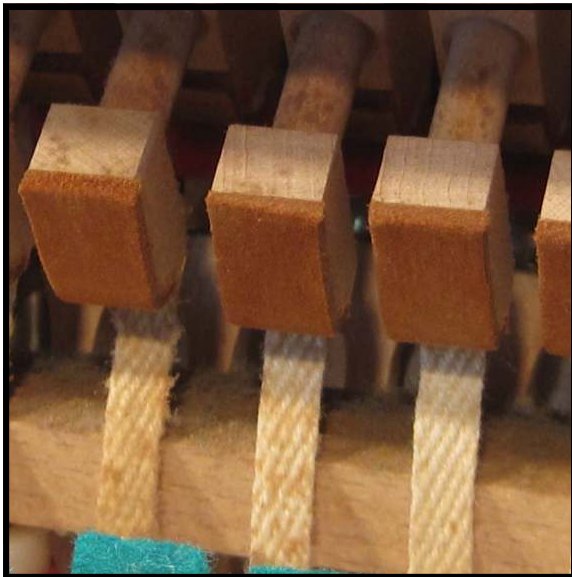
*Old hammer butts*

Consider the above photos showing a part called the catcher, which is faced with a buckskin (or similar) covering. When a note is played, this part is essential to preventing repeated strikes (called "bobbling" notes). The buckskin surface wears thin over the years, especially on portions of the keyboard which are played more heavily. In the photo on the left showing a set of original hammer butts, the buckskin covering the center catcher has worn thinner than the two adjoining catchers. The photo on the right shows the new catchers of replacement hammer butts. Not only is the buckskin covering uniform in thickness, providing a consistent cushion to the parts coming together, but it has a better ability to make a secure contact with the backchecks (the thick green felts at the bottom of the photo). The rougher texture of the new buckskin will grab the backchecks without slipping, as older, worn buckskin is prone to do.

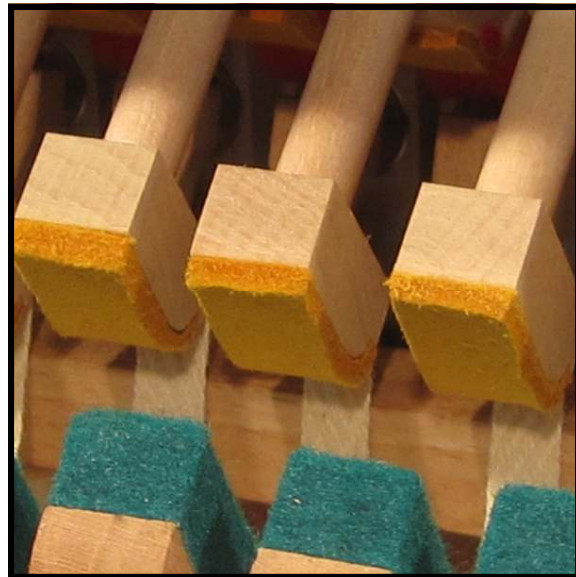
*Replacement hammer butts*

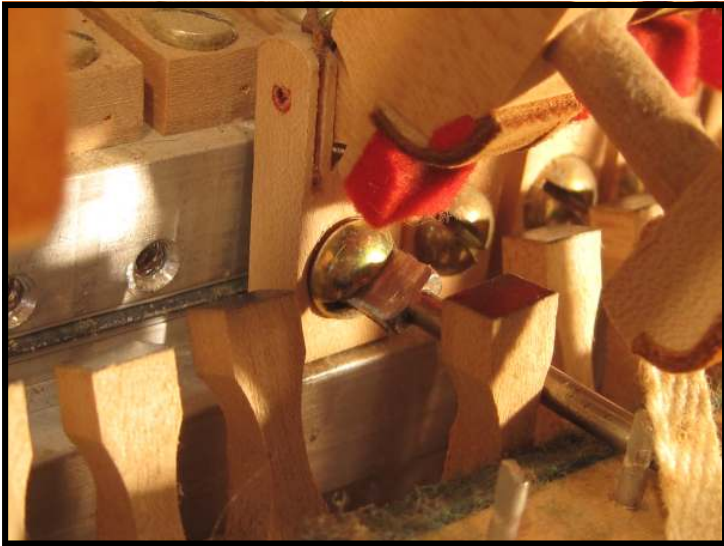
The first step is to remove the original hammer butt / flange assemblies from the piano action. These are taken from the action by carefully unhooking the bridle straps, then backing out the flange screws holding each assembly in place so that each unit may be lifted out.

Since extensive disassembly is required, care is taken to make sure that parts go back together properly. When a section of hammer butt / flange assemblies is removed, for example, key assemblies are left in place to line up the parts as they are returned to the action.

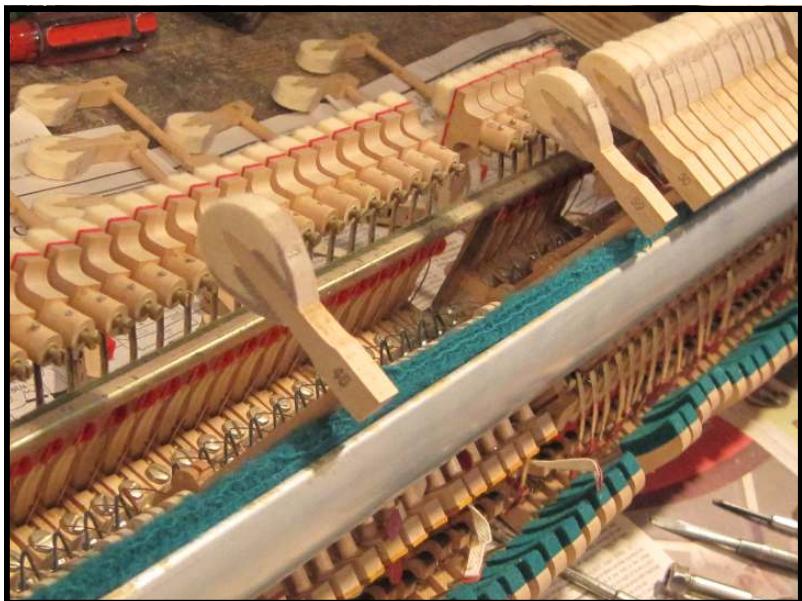
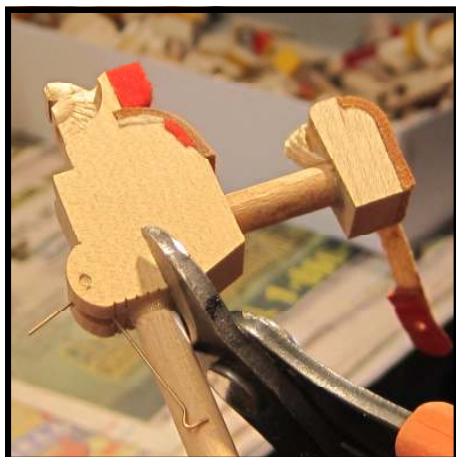
The old hammer butts are then removed from the hammer shanks, usually by using a pair cutters to cut along the grainline. Several cuts are required to remove the old part, at which time the shank needs to be cleaned of any remaining wood and glue.

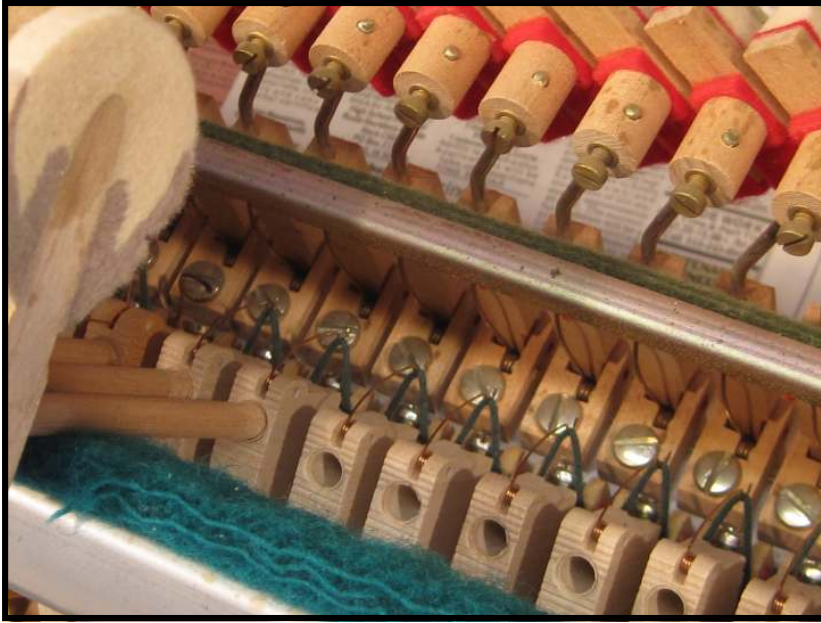
The hammer shanks are then dry fitted into the new hammer butt assemblies. With all the hammers in place, careful alignment will be done, and only then will the parts be glued together.

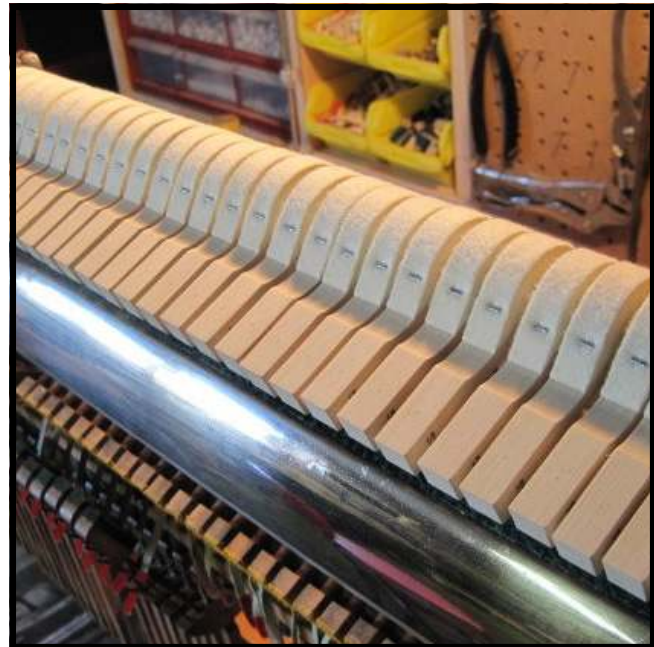
For the best results, worn hammers must be either shaped or replaced. Old hammers have often been badly cut into by the strings of the piano, resulting in them having an outer layer of felt which is dead or pulpy. By carefully removing the outermost layer of felt, hammers can be brought back to life. For badly worn hammers, replacement will give the piano a new lease on life. With either hammer reshaping or replacement, time will be needed to voice the hammers for consistent tone.

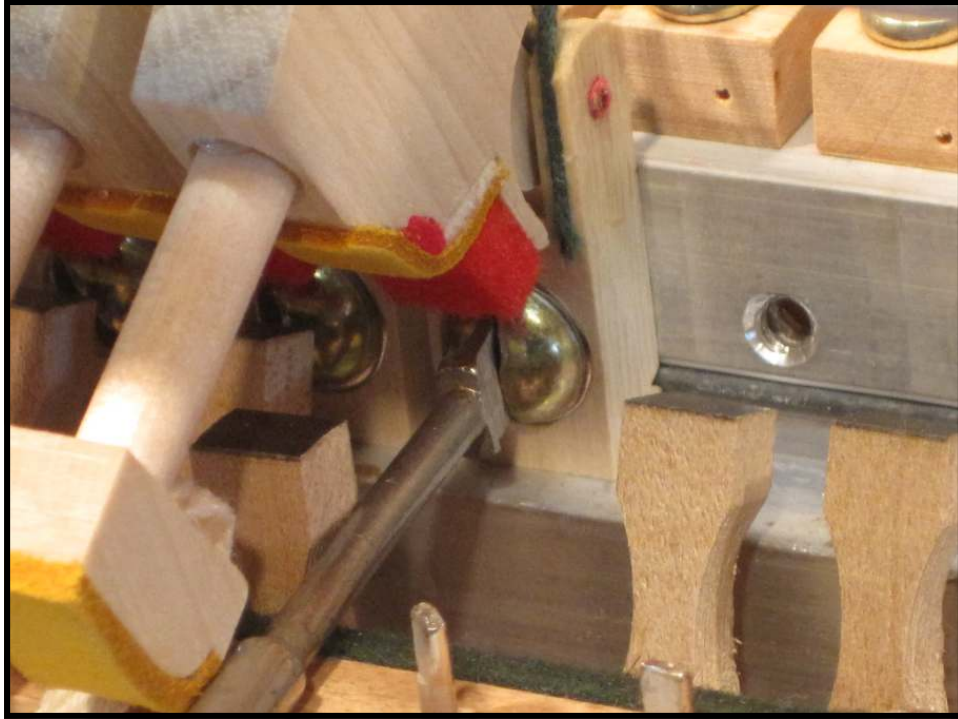
*New hammer butt / flange assemblies being installed.*
