# The Owner's Guide to Piano Repair

## Focus On: Refelting the Keybed

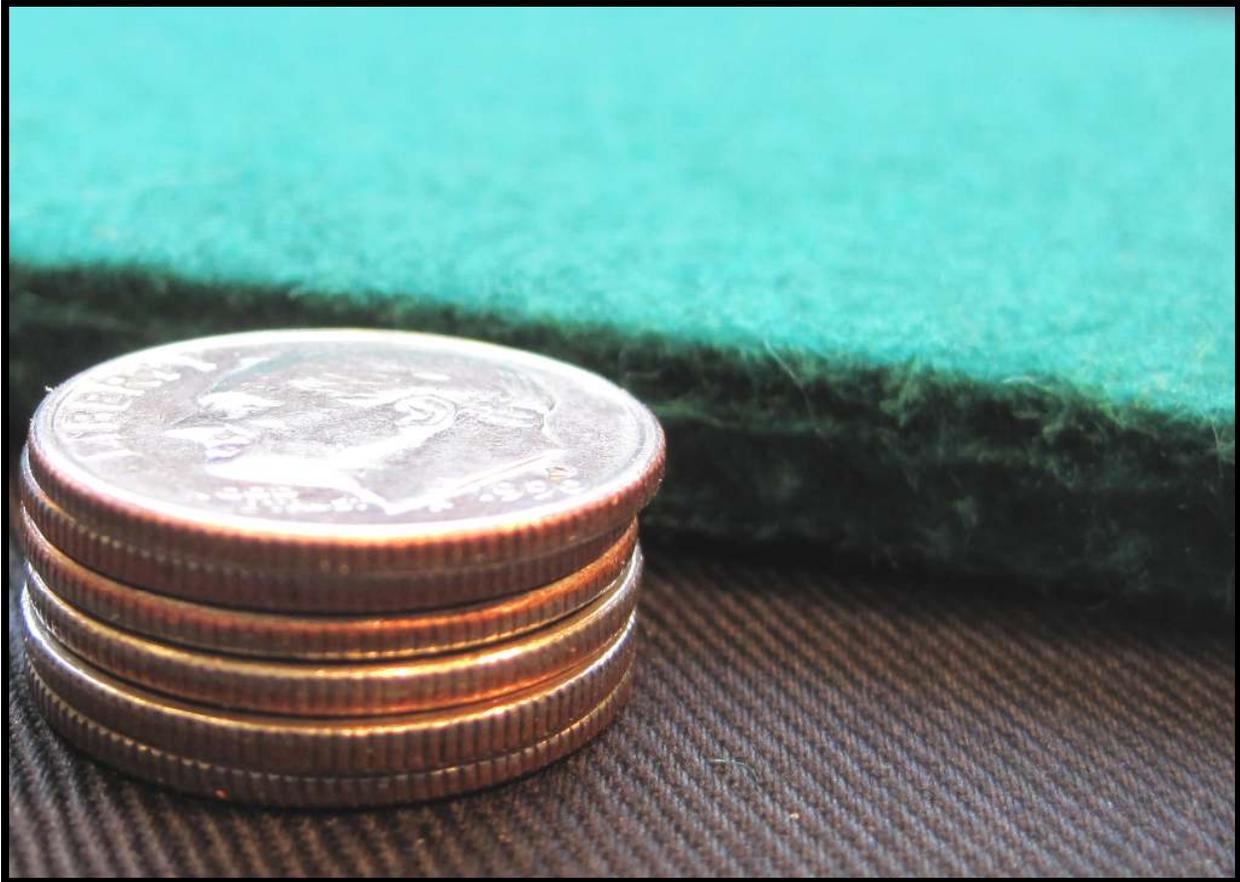
*The thickness of heavy backrail cloth equals that of six dimes.*

Very much so. As illustrated in the photo above, the felt used for backrail cloth (as well as balance rail and front rail punchings) is a very thick, dense felt that is designed to stand up to decades of constant use.

Keybed felts come in a range of thicknesses, so that the original size of the felt installed at the factory may be duplicated. Paper and card punchings as thin as .002" are used under the felts for final adjustments necessary for level keys and even key dip.

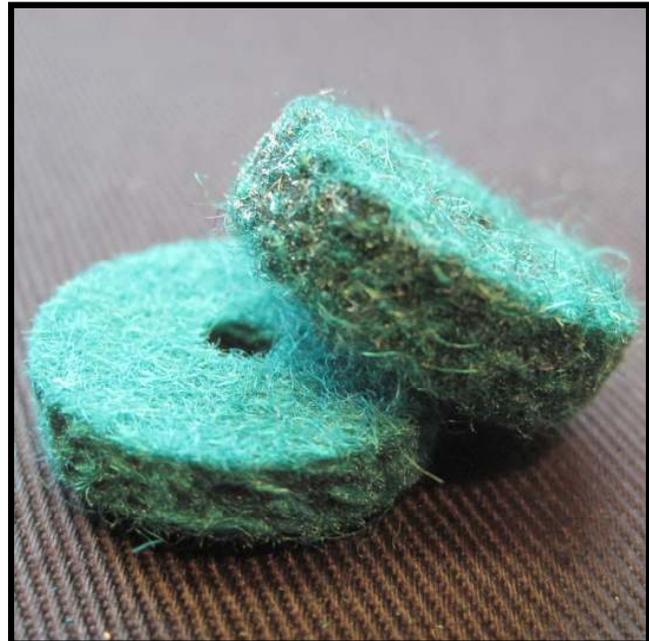
*Thinnest and thickest front rail punchings.*
